SIDDERS MODIFICATION FOR ACRO II AILERON BELLCRANKS

Neil Sidders
235 Rowland Road
Monroe, LA 71203

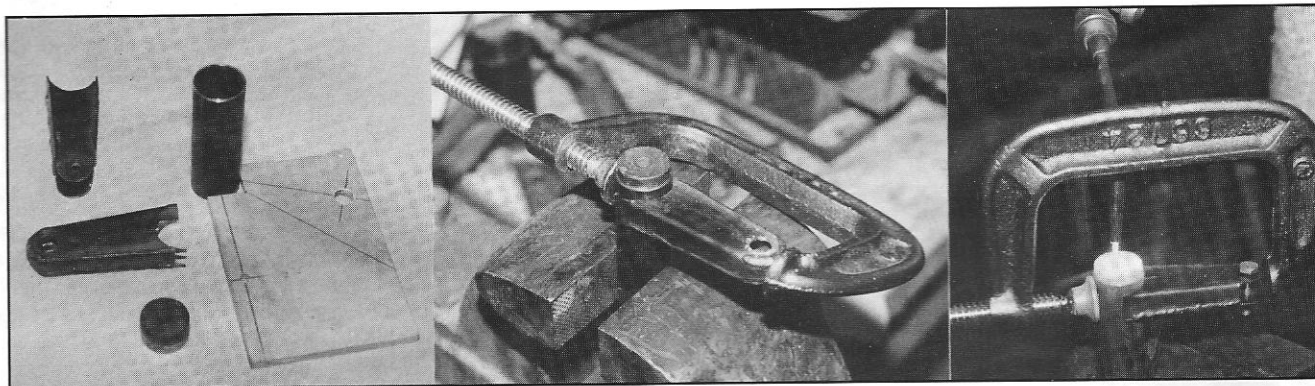
The steel slug is for insertion only during welding. Heat the slug before welding lever.

^{SPACER}
Locate the bearing in the bearing sleeve as per the plans. Then tap the slug in until it contacts the spacer, clamp the lower arm to the bearing cage and prepare to weld. Start the weld by heating the slug to a bright red. This will allow you to weld the lever to the sleeve without losing your heat to the slug. After the part cools, you can knock the slug out and it will leave a good clean hole for the bearing.

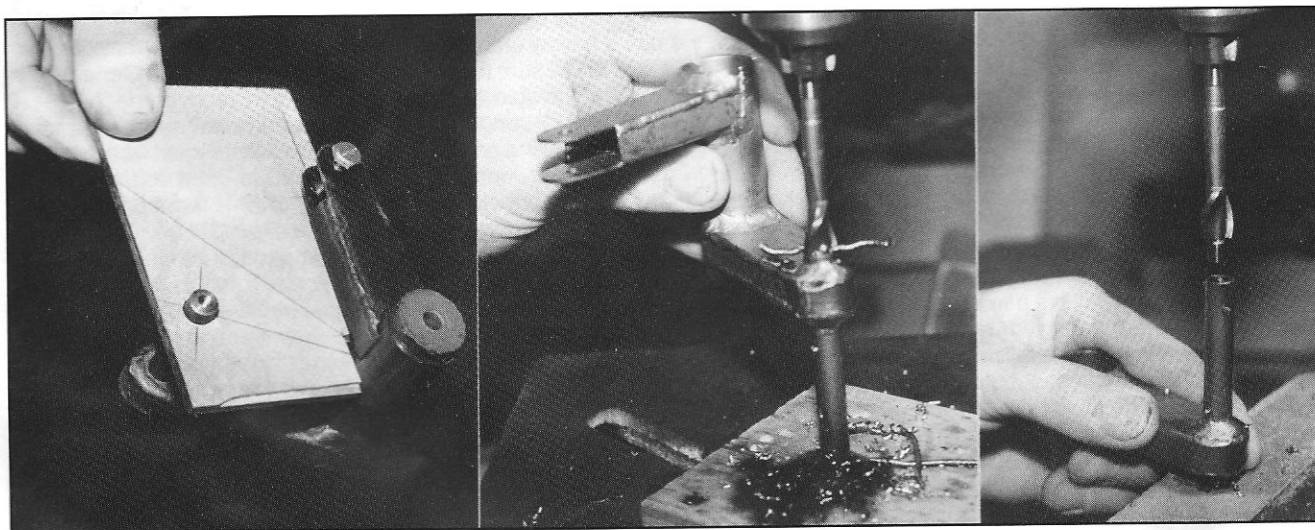
Plywood gauge to locate bellcrank levers. Squaring off ends of busing stock.

you?), and locate the upper lever as in the photo. Clamp the lever to the bearing cage with the slug in place and repeat the welding steps.

If there is a weak link in the aileron control system, it is the rod end at the bottom of the bellcrank bushing stock. It is extremely important that the end of the bushing stock be very square to the bore to reduce the bending loads on the AN-3 bolt. All the other rod ends are driven on both sides of the Uniball which is great because it eliminates the bending loads altogether. We used a Tu-Lip counter bore to spot off the end of the bushing stock after it is reamed to size.
