Cracked MS 21042 / NAS 1291 - Series Nuts -  
Hydrogen Embrittlement

**AWB** 14-002 **Issue** : 1  
**Date** : 12 October 2011

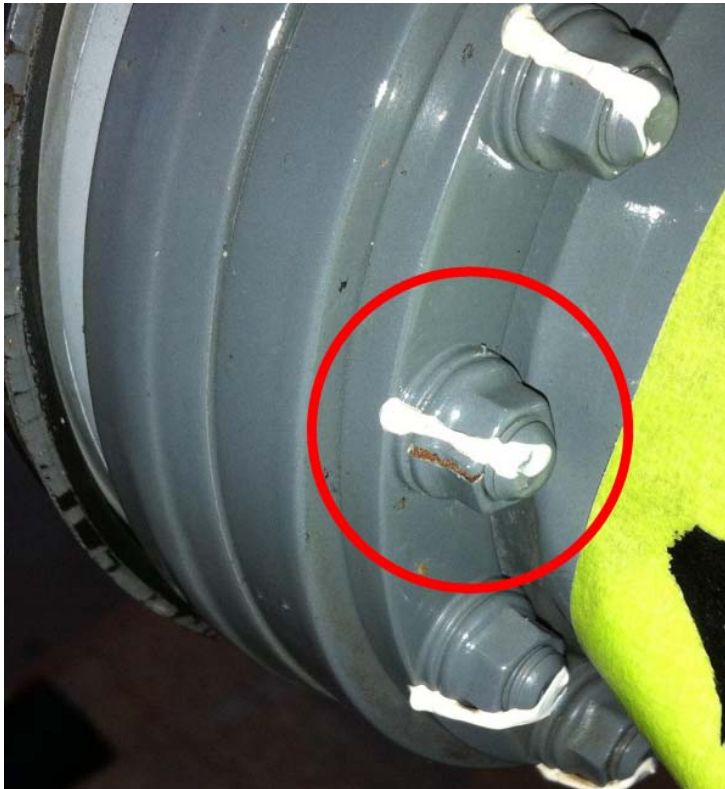
These failures are typical of hydrogen-induced delayed cracking (hydrogen embrittlement), a condition resulting from the presence of hydrogen in the steel (attributed to improper heat treatment at manufacture or following re-plating<sup>iv)</sup>) and a sustained tensile stress. The stress is induced from the moment the nut is torqued and may fail hours, days or weeks later, with one or more cracks appearing approximately in-line with the longitudinal axis of the nut, frequently splitting the nut wide open but staying in place, as if it were serviceable.

When the nut has failed in this way, it no longer functions as designed and it releases all the tension on the stud or bolt. This failure may have serious secondary effects. The bolt to which it was attached may fall out and/or as with the R22/44 main rotor blade cuffs, higher loads are now immediately transferred to the remaining fasteners, which may result in over-loading and subsequent failure of the bolts or studs some time after the nuts have been replaced.

Figure 1 - Example of a failed nut (Courtesy ATSB)

- (a) pilots and maintenance personnel closely monitor the occurrence of hydrogen-induced delayed cracking in high-strength steel standard aircraft hardware, such as nuts via close inspection following installation and thereafter at Daily / Preflight and periodic inspections.

- (b) Before simply replacing cracked/failed nuts with new items, consider contacting the manufacturer for advice regarding replacement of associated fasteners which may have suffered over-loading as a result of the failure of one or more nuts.
- (c) Report all MS 21042 and NAS 1291 series nut failures to CASA via the SDR system.
