ACRO SPORT II MODIFICATIONS

By Neil Sidders of Monroe, Louisiana, Contributing Editor

EDITOR'S NOTE: Neil Sidders, Bruce Owens and Robert Owens are building three Acro Sport IIs. The photos that follow were not taken from just one aircraft.

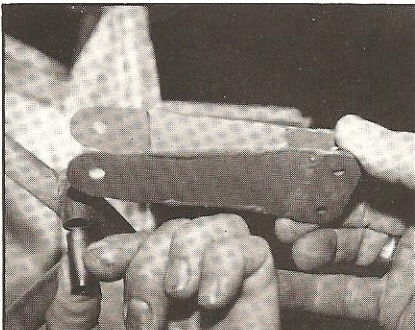
In the Acro Sport plans, all the idler fittings in the elevator push pull tube assembly swing on a 1/4" AN bolt that is pushed through a short length of bushing stock that is welded into the airframe. If these bolts are torqued to their proper values, it will lock the system. What it should have is a bushing within the welded bushing stock with the inner bushing about .020" longer than the welded bushing material. We used heat treated steel bushing stock in the idlers, and the system is very smooth and has no slack at all.
